# **POWER QUALITY ASSESSMENT OF SOLAR PHOTOVOLTAIC INVERTERS**

The Living City Campus, Vaughan, Ontario

Final Report

January 2016

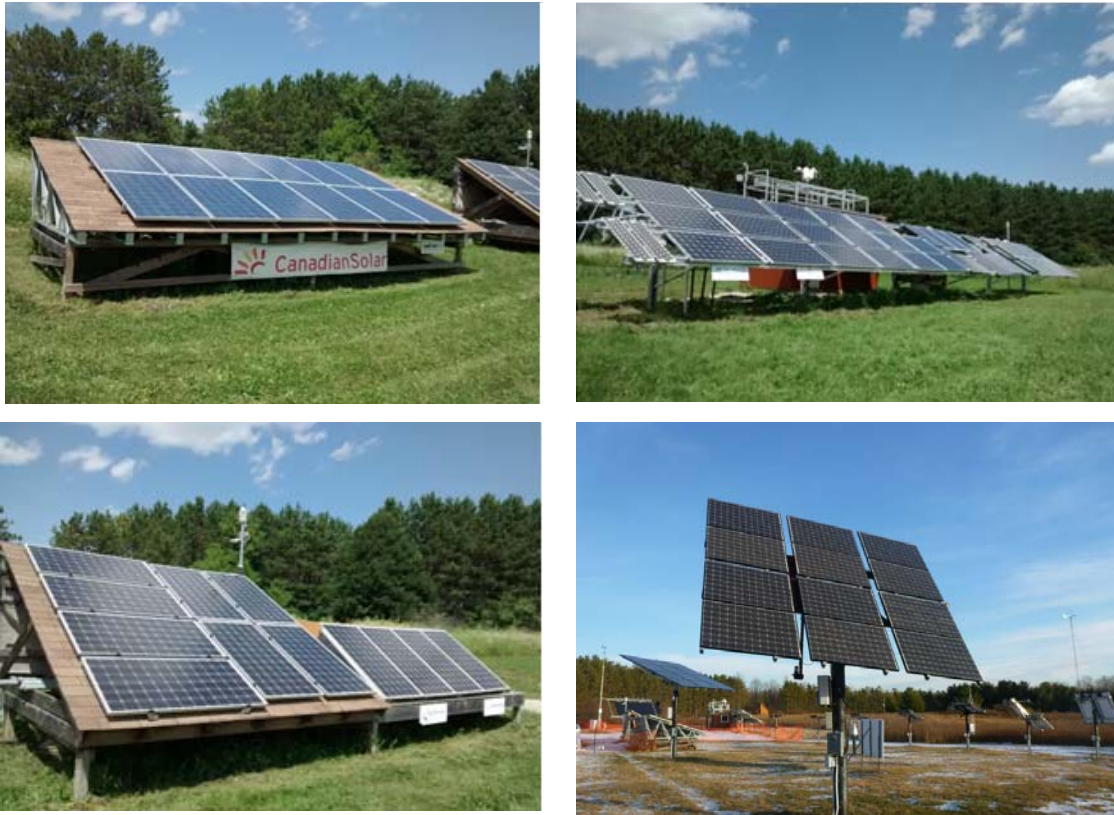
**Figure 3.1.2:** Travelling clockwise from the top left, example PV arrays connected to Inverters A to D are shown, respectively. In the case of Inverters C and D, there are actually multiple inverters and therefore, those presented here are not exhaustive of all inverters on the property.
